Coventry Lake – Hydrilla Management Program

2017 Final Report

February 2018

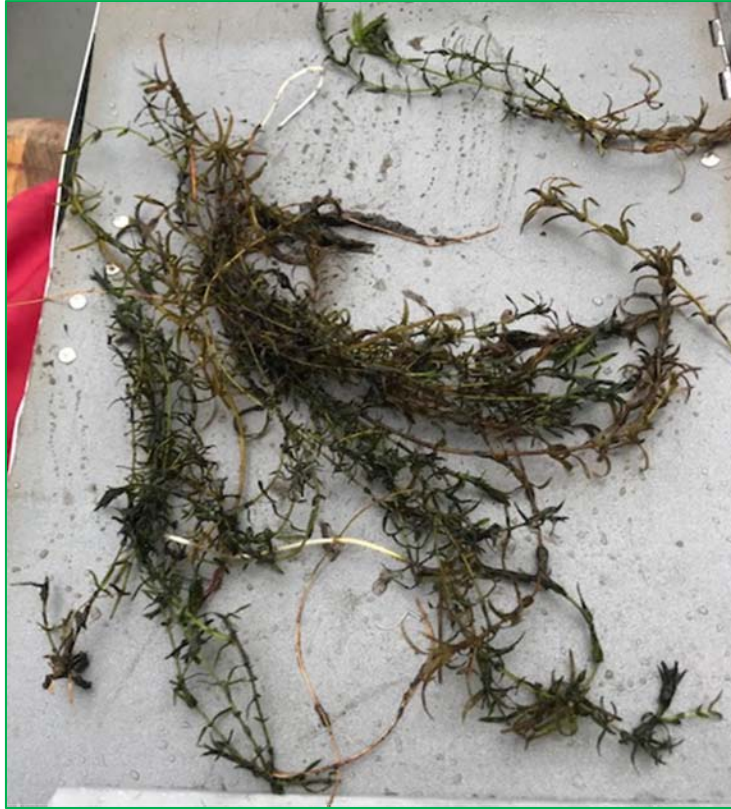
Photo 1: November 20, 2017 - Treated Hydrilla Partially Decaying

- No Hydrilla was visible from the surface near the outlet cove (untreated) nor boat ramp area (treated 2017).
 - Several ~10'-pole hand rakes revealed no Hydrilla, but throw-rake tosses were not conducted to avoid potential fragmentation.
- One of the original patches (northern eastern most) in the island cove area (treated in 2016 and 2017) still had Hydrilla present.
 - Hydrilla plants appeared to be partially decaying - Photo 1 – Page 11.
 - Due to choppy water and low temperatures, no other beds were inspected on this date.

Given this expansion and concerns with the current approach, whole lake treatment with fluridone should be considered. Although more costly than the current approach, whole lake treatment will provide excellent, lake-wide biomass reduction and thus eliminate the reliance on locating and treating specific areas of Hydrilla growth. In fact, if started at the optimal time (June), there should not be any appreciable Hydrilla biomass in the lake at any point in the season.
